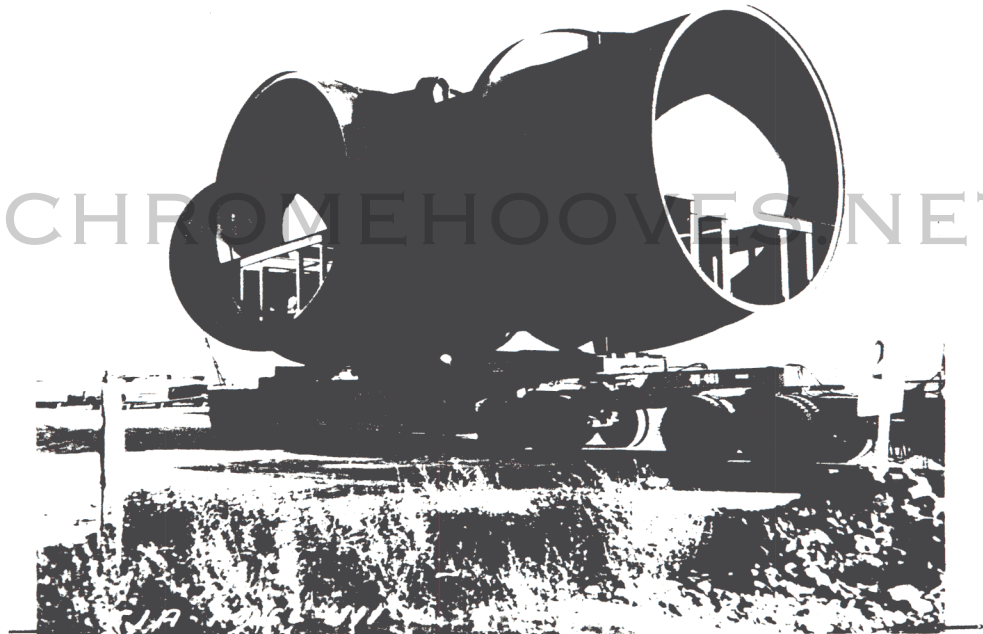
Part of Tunnel Junction No. 10 on arrival at
Complex 1-A, 16 February 1961. (Figure 22)
