5. REINFORCING AND STRUCTURAL STEEL

6. CONCRETE OPERATIONS

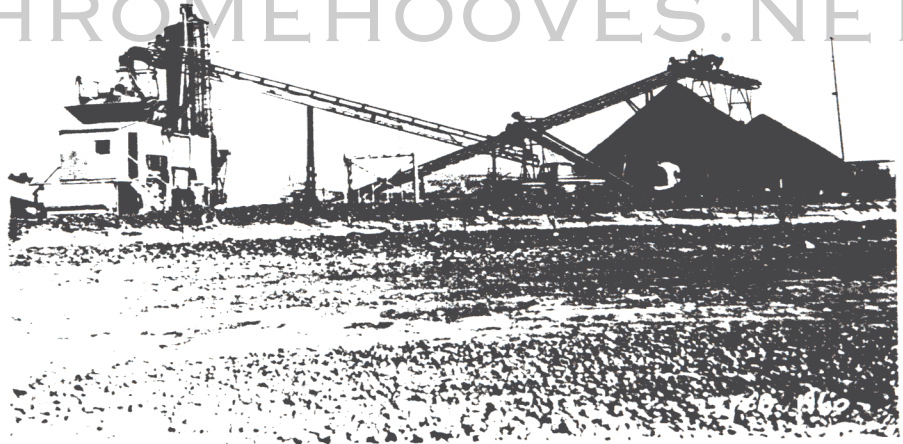
Complex 1-A Concrete Batch Plant and Aggregate Stock Pile - Feb 60 (Figure 18)

Concrete plants were set-up at each complex for batching of the various concrete mixes. The plants were of the dry batch type charging truck mixers.

Batch plant models were:

a. Complexes 1-A and 1-C - Noble Mobile Type, Rated Capacity, 75 c.y. per hour.
