PLS SYSTEM COMPONENTS

Representative photographs of the Propellant Loading System follow.

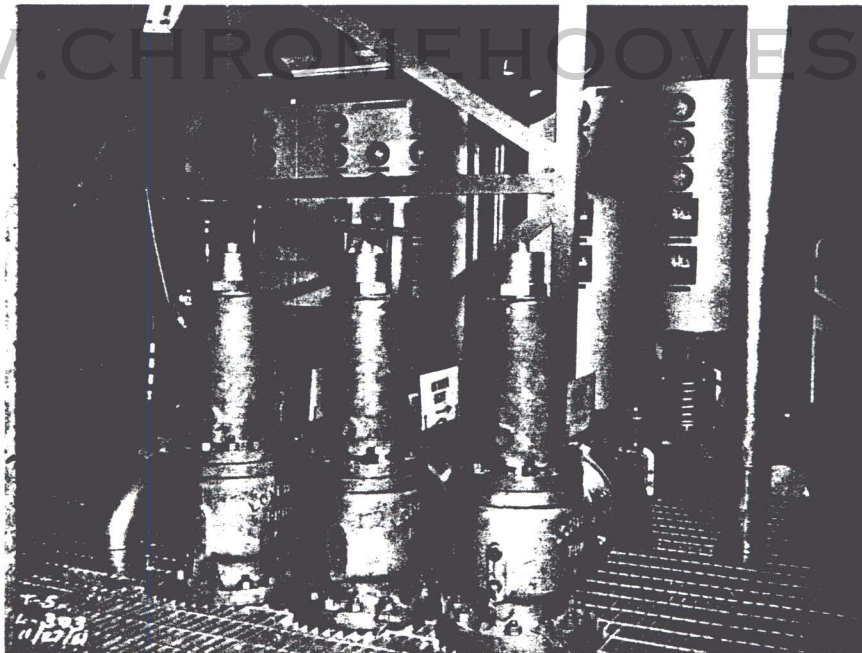
Fig. 92  
Propellant Terminal, Main Deck (Completed installation of  
LOX tank safety valve manifold)(Transfer panels in  
background)

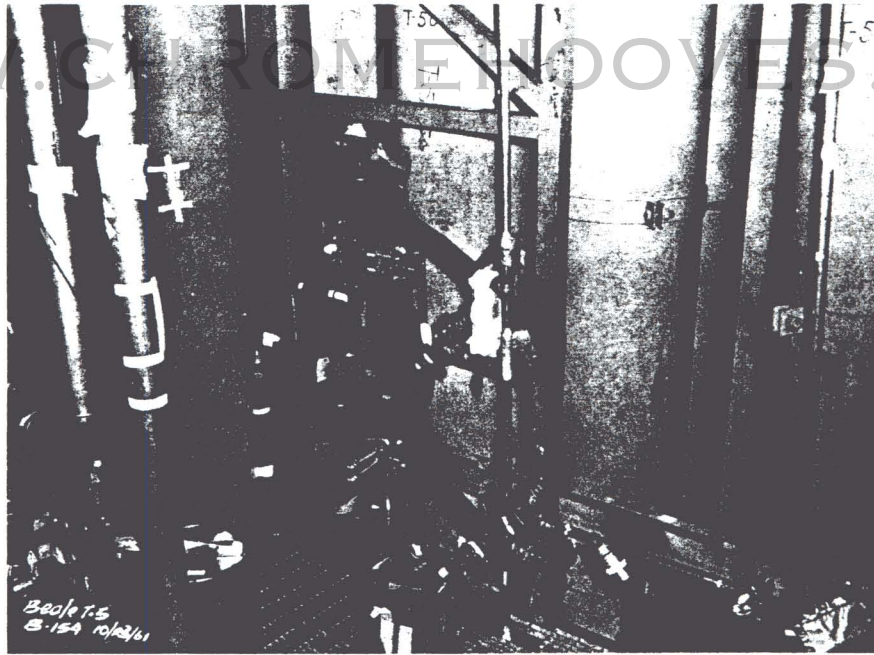
Propellant Terminal, High Pressure Gaseous Bottle Cluster and Control Manifold Fig. 96

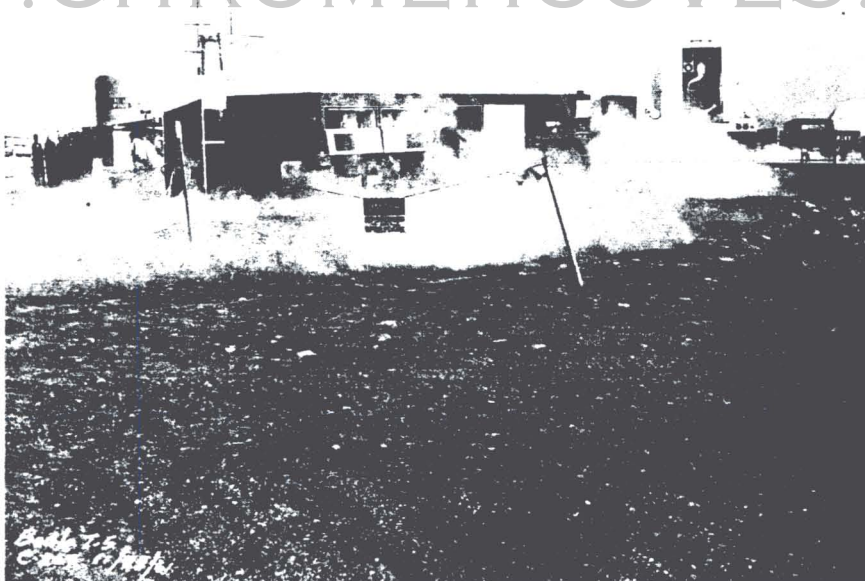
Fig. 98

PLS Testing Equipment (High Pressure Recharger and Liquid Nitrogen Storage Tank)

The equipment furnished provided the necessary quantities required for the testing program. All equipment performed satisfactorily except for the liquid filters. The problems encountered with the filters were discussed previously in connection with the Government furnished liquids.
